Manhole Inspection Summary

Manhole # S09A1_020MH

Location Address: **1236 Harvelhill RD**

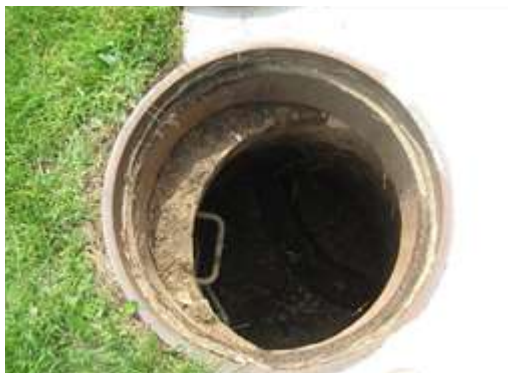
Frame View

Condition: ☒ Sound ☐ Cracked ☐ Leaks

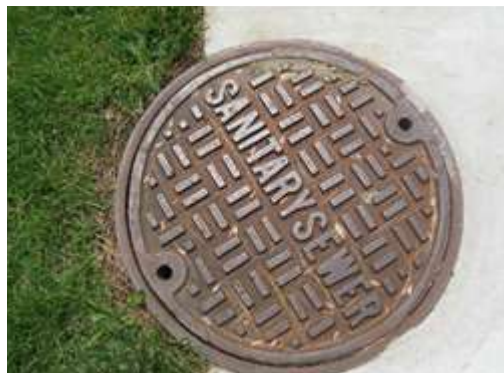
LID PIC

Condition: **Sound**

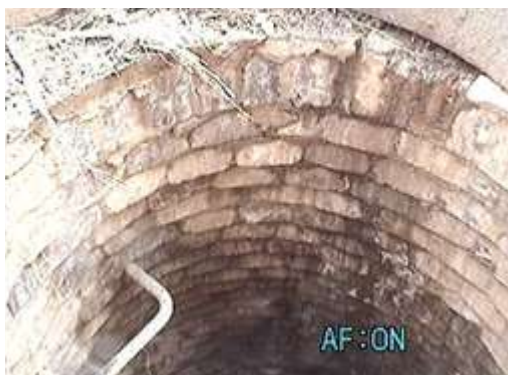
Defect 1

Infiltration: ☐ None ☒ **Joint** ☐ Cracks ☒ **Mortar** ☐ Roots ☐ Wall

signs of infiltration @ FRAME
-CHIMNEY CONNECT

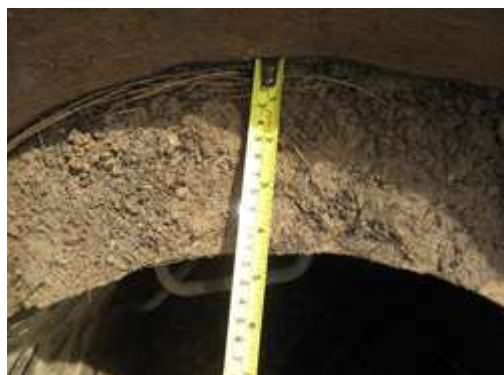
Defect 2

Offset: **4.5** (in.)

OFFSET 4.5 INCHES

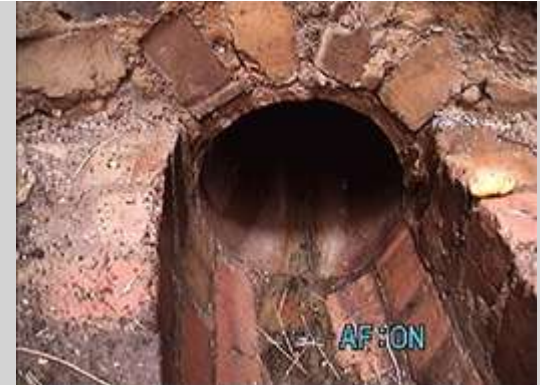
12 O'Clock Outflow

8 in. Circular Gravity Sewer
Pipe Out @ 12 O'Clock

Infiltration: **None** Pipe Seal Cond: **Sound**

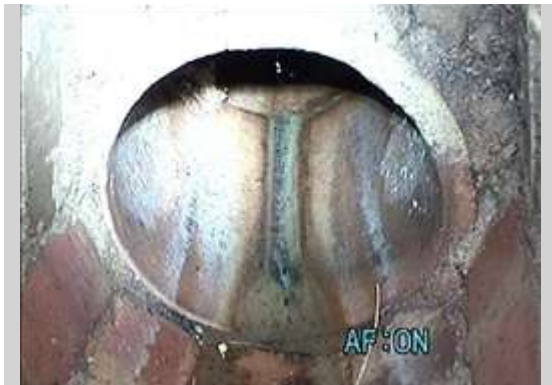
5 O'Clock Inflow

6 in. Circular Gravity Sewer
Pipe In @ 5 O'Clock

Infiltration: **None** Pipe Seal Cond: **Sound**
